***EVALUATION OF
SECURING PROCEDURES FOR
MOBILE OFFSHORE DRILLING UNITS
WHEN THREATENED BY HURRICANES***

Final Report

(REPORT NO. H3348/NDAI/CAC)

February 9, 1995
Job No. 93625

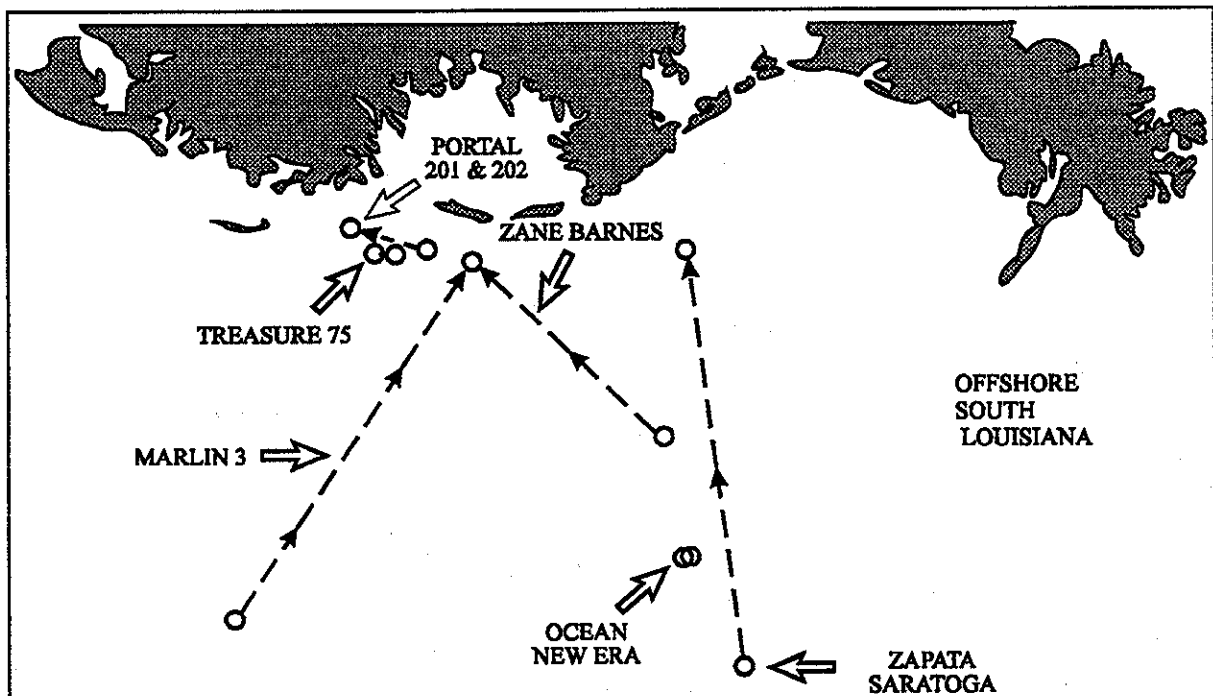
Figure 2.1 MODU Movement During Hurricane Andrew

Andrew passed through the central South Timbalier region offshore Louisiana and caused the most extensive damage to both fixed platforms and semi-submersibles to date. With a total of eight semi-submersibles located within the path of the storm, three rigs broke or dragged their moorings and damaged various platforms and pipelines. These rigs were:

"ZANE BARNES", which broke all 8 mooring lines, drifted approximately 30 miles to the north-west and toppled a platform, interfered with several pipelines (some of which may have been damaged prior to the arrival of the *"ZANE BARNES"*) and collided with a second platform (which may also have been damaged prior to its arrival).

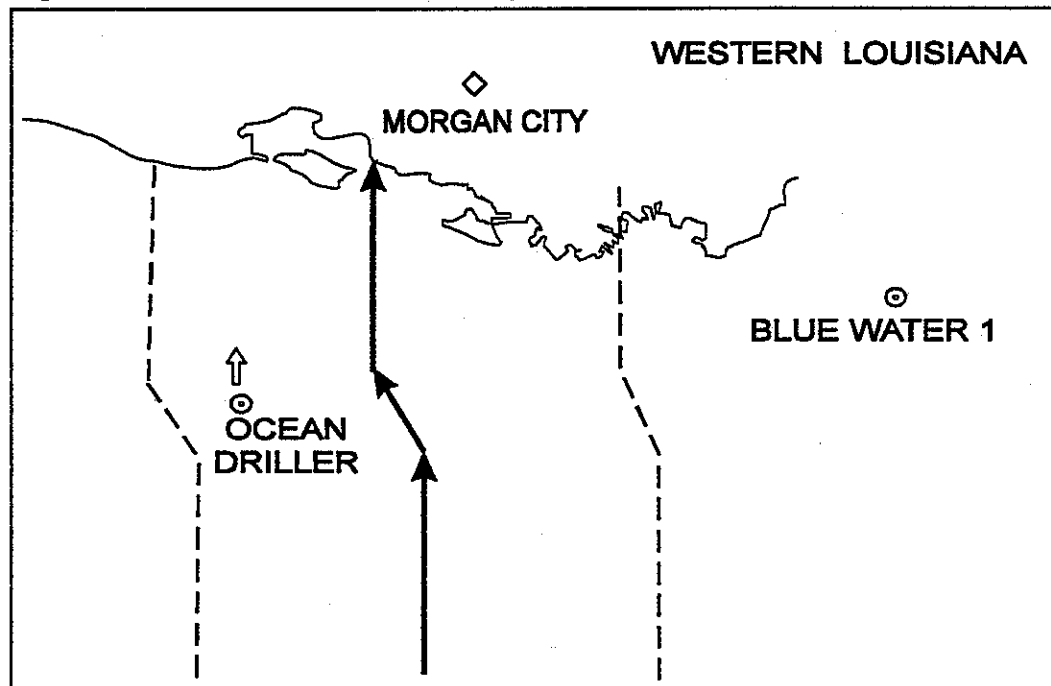
Figure 3.1 Hurricane Hilda '64 Category 4

Hurricane Hilda was the first hurricane which exposed modern moored semi-submersibles to hurricane forces. Just prior to Hilda, there were three moored drilling rigs off Louisiana. The most fortunate was the "*GLOMAR 4*", a drillship, which moved quickly inshore to Lake Charles where it rode out the storm. The "*BLUE WATER 1*", the first industry's semi-submersible, was some 100 miles to the east of the path of taken by the eye of the storm. After the storm, the "*BLUE WATER 1*" was found floating upside down in the middle of its moorings due to a structural failure caused by tornadoes spawned from the hurricane. The "*OCEAN DRILLER*" located about 30 miles east of the path, broke two of nine chains and dragged the rest for 10 miles. A crew of 14 safely rode out the storm.³ Industry practice in the Gulf of Mexico is to evacuate offshore rigs during hurricanes, and this was the only documented instance in the Gulf of Mexico of personnel remaining onboard a semi-submersible during a hurricane of this strength.

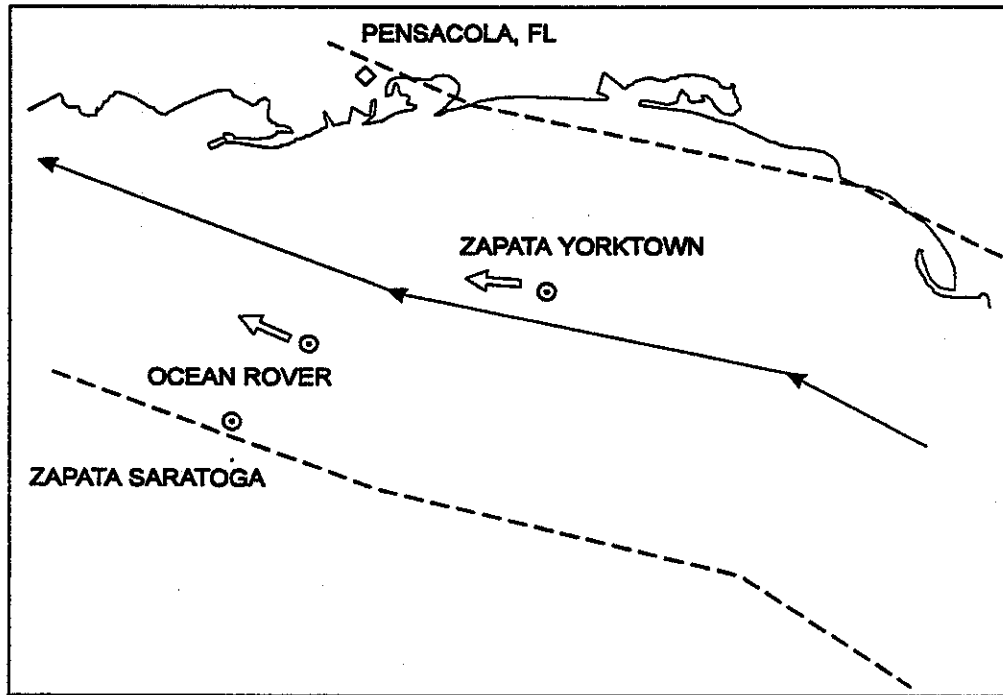
Figure 3.10 Hurricane Elena '85 Category 3

Elena initially moved toward the western coast of Florida, turned around, and ran parallel with the Panhandle until it hit landfall in Western Louisiana. There were two semi-submersibles, "*ZAPATA YORKTOWN*" and "*OCEAN ROVER*", working the Destin Dome region at the time, and both were set adrift by the storm.⁴ Due to the distance to the nearest port, these units were unable to move inland prior to the hurricane. No damage resulted from either of these incidents which could be attributed to the lack of offshore structures in the Destin Dome region.

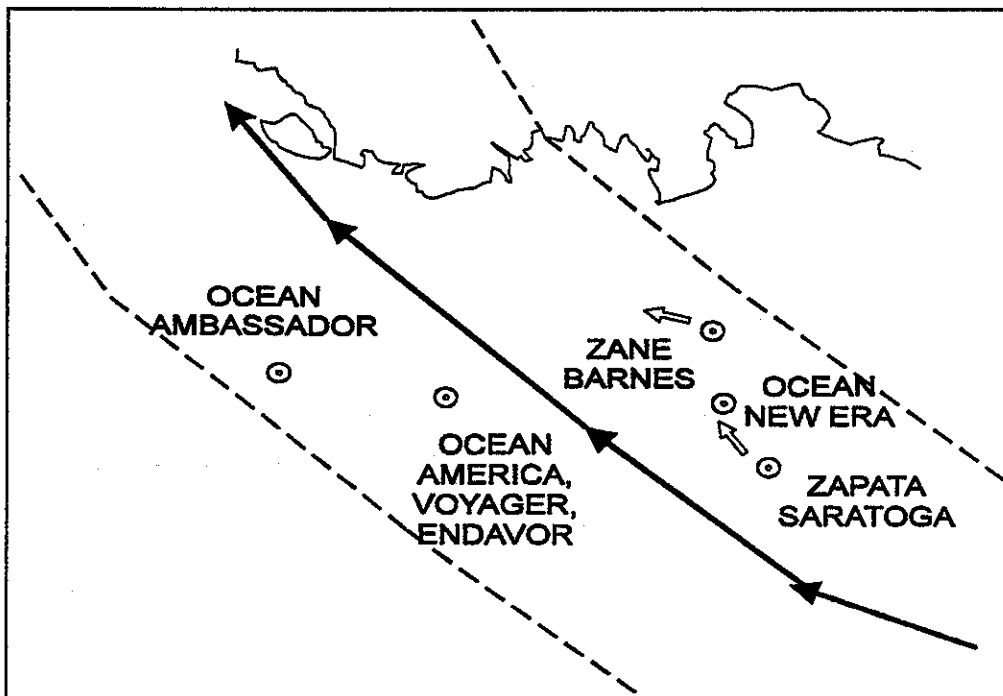
Figure 3.11 Hurricane Andrew '92 Category 4

Of all the rigs examined, the "*ZANE BARNES*" is the only one for which the details of the mooring system deployed are known. The exact orientation of the rig, line scope, and line tension at time of abandonment enabled a detailed mooring analysis to be conducted. The outcome of the analysis showed that in the meteorological condition during Andrew, the rig's calculated line tensions exceeded the line catalog break strength by over 50 percent.

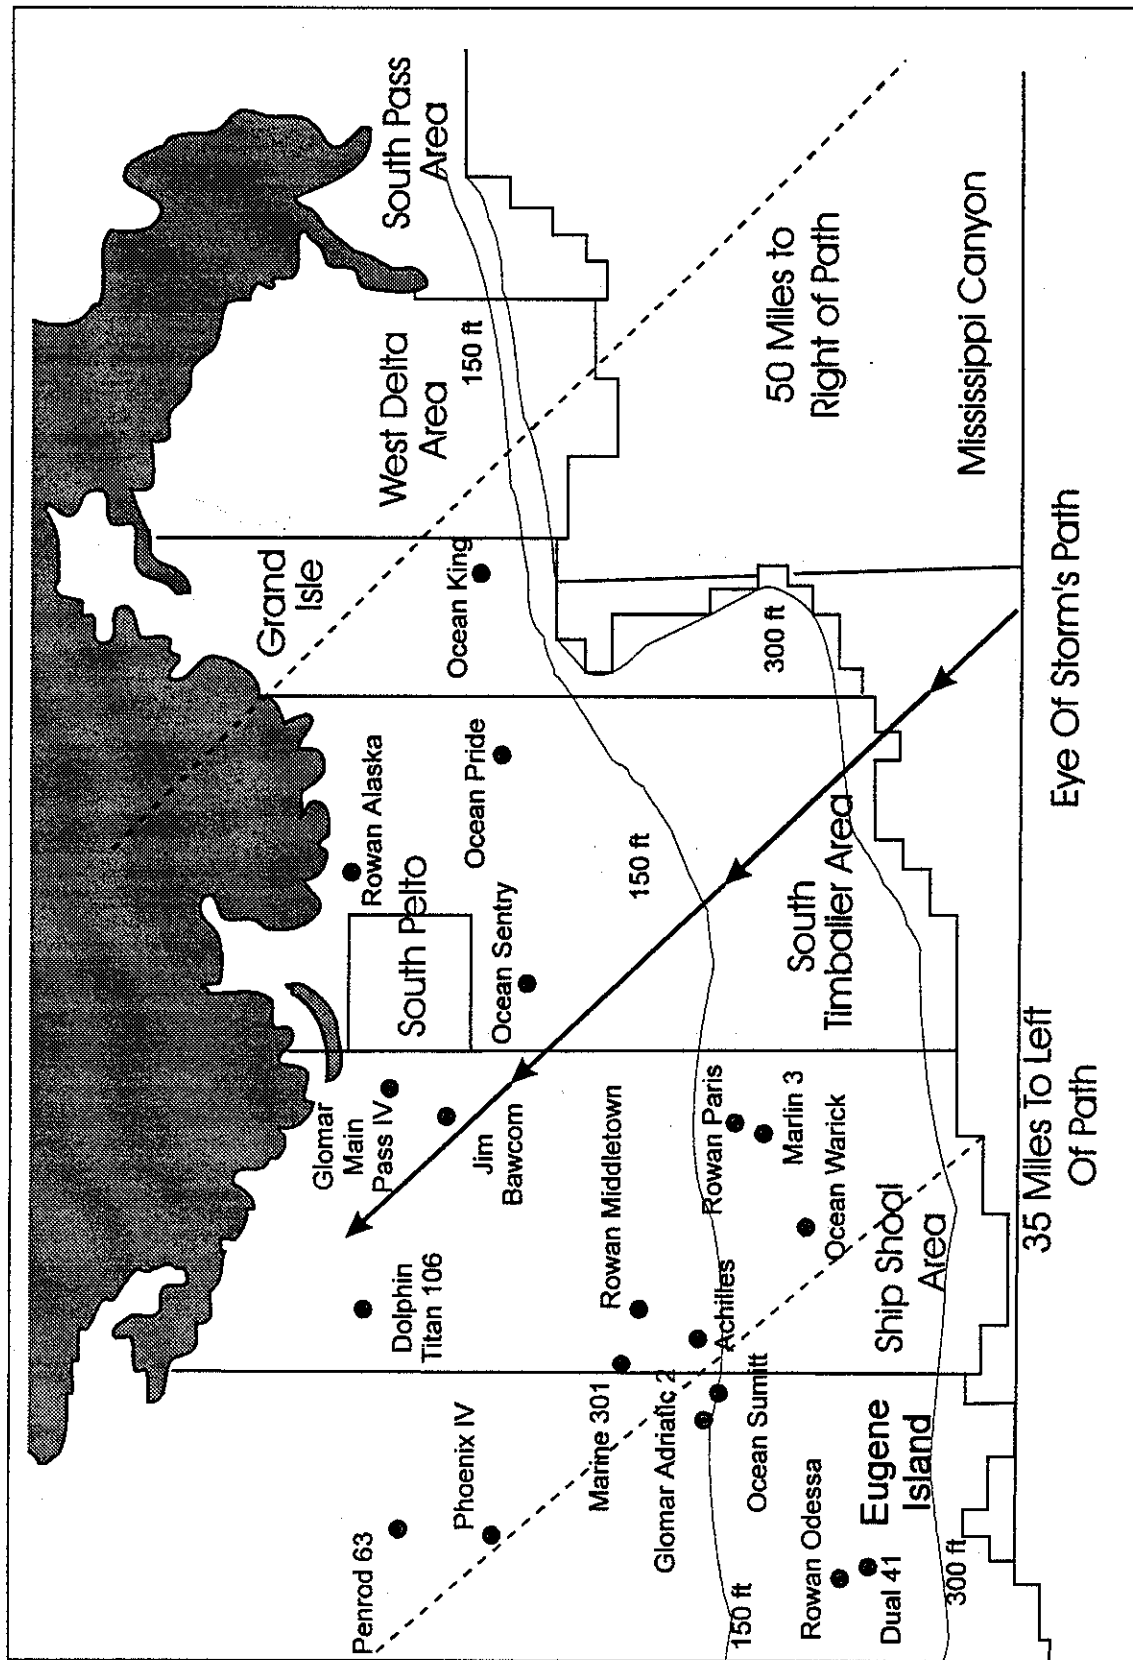
Figure I-1 Jack-Up Positions During Hurricane Andrew

Name	Type	Water Depth	Estimated Maximum Weather Encountered
<i>DUAL 41</i>	F & G Mod II	260 ft	Wind 65 kts Wave 32 ft
<i>ROWAN ODESSA</i>	Let 116-C	248 ft	Wind 65 kts Wave 32 ft
<i>OCEAN WARWICK</i>	Lev 111	240 ft	Wind 80 kts Wave 47 ft
<i>ACHILLES</i>	BMC JC-250-MC	145 ft	Wind 80 kts Wave 45 ft
<i>ROWAN MIDDLETOWN</i>	Let 116-C	100 ft	Wind 90 kts Wave 45 ft
<i>OCEAN PRIDE</i>	Beth 150-MS	96 ft	Wind 110 kts Wave 60 ft
<i>MARINE 301</i>	F&G Mod II	65 ft	Wind 80 kts Wave 43 ft
<i>OCEAN SENTRY</i>	Beth JU-200-MC	54 ft	Wind 110 kts Wave 60 ft
<i>HERCULES</i>	Beth JU-100-MC	54 ft	Wind 110 kts Wave 60 ft
